## Seismic vulnerability of dwellings at Sete Cidades Volcano (S. Miguel Island, Azores)

A. Gomes, J. L. Gaspar, G. Queiroz

Received: 19 July 2005 – Revised: 7 October 2005 – Accepted: 7 October 2005 – Published: 10 January 2006

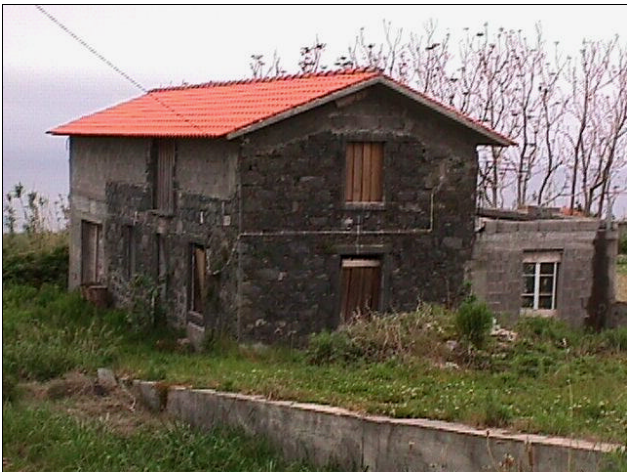
however the majority of the recent houses are built with blocks of concrete mixed with fine volcanic materials, such as basaltic lava and scoria fragments. Another point that came up during the field survey was related to the observation that several old dwellings had suffered recent interventions, in most of the cases to increase the number of rooms or even floors. For example, it was detected that some dwellings have sections where the external walls are made from loose or weakly cemented stones, while other sections are built with concrete blocks (Figs. 8 and 9). Houses in these conditions were considered to be of class A, due to the different behaviour of the structure in response to a seismic solicitation.

**Fig. 8.** Dwelling with external walls in stone and in concrete blocks.

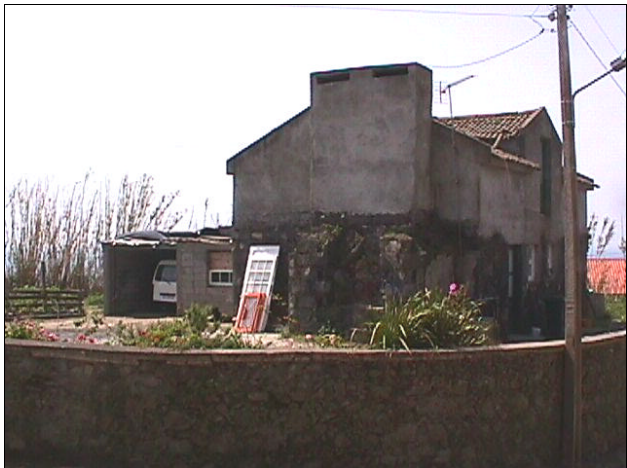
**Fig. 9.** Dwelling with external walls both in stone and in concrete blocks.
